AVIATION INVESTIGATION REPORT

A00C0060

LOSS OF CONTROL – COLLISION WITH TERRAIN

CESSNA 180J C-GRPR

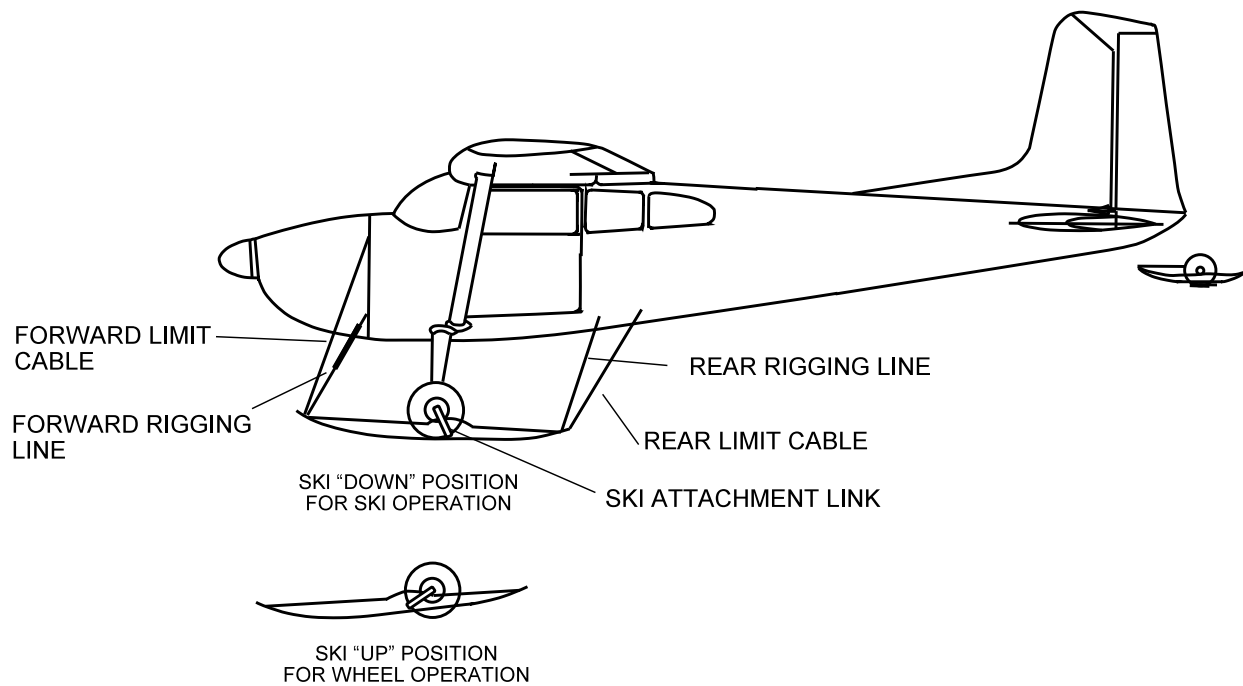
Appendix A - Aircraft Diagram

The aircraft's landing gear configuration was converted from floats to skis on 01 December 1999, and the aircraft had operated for 67 hours since that time (see Appendix A). The Federal Fluidyne C3200 wheel-skis that were installed were inspected before installation, and no defects were found. The skis were equipped with hydraulically operated attachment links that allow the skis to be retracted for wheel operations or extended for ski operations. Most of the take-offs and landings made since the skis were installed were made from lake surfaces near the pilot's home and at several other camp locations. The landing strip near the pilot's home had been mechanically smoothed, but the other locations were unprepared. During these operations, the skis occasionally encountered small snow drifts and irregular snow surfaces. The pilot usually stored the aircraft in a hangar adjacent to the landing strip between flights. His practice was to retract the skis to taxi the aircraft on land and into the hangar. He would extend the skis again for operation on the lake landing strip. The skis were normally retracted in flight for aerodynamic efficiency; however, the skis were left in the extended position during the accident flight.
